**FINAL REPORT  
OCTOBER 2003**

**REPORT NO. 03-11**

**SMART TIE-DOWN SYSTEM,  
TP-94-01, REVISION 1, JULY 2002  
"TRANSPORTABILITY TESTING PROCEDURES"**

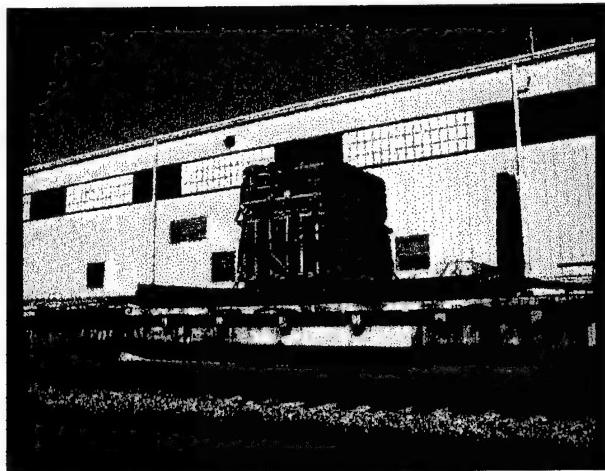
**Photo 2. Rail Impact Testing of Smart Tie-Down with SCL #23 Load Bay.**

1. Figure 5 lists the average speeds of the specimen car immediately prior to impact with the anvil. Impact #1 was determined to be a "no test" due to the inadequate impact speed (minimum 4 mph). Impact #5 is the reverse impact.
2. Following Impact #3 the payload moved 0.13 inches in the direction of impact.
3. Following Impact #4 the center base pallets of 155MM Projectiles moved in the direction of impact 1 inch. The outside pallets of 155MM Projectiles moved 0.25-0.5 inches in the direction of impact.
4. Following Impact #5 the center base pallets of 155MM Projectiles moved 3.75 inches in the direction of impact. The outside pallets of 155MM Projectiles moved 1.25-2.5 inches in the direction of impact.

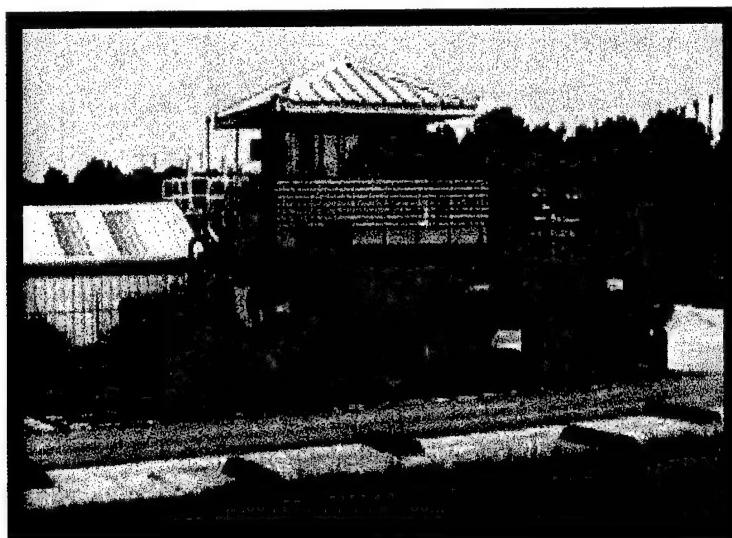
1. The Smart Tie-Down System was retensioned prior to the start of the Washboard Course.
2. The load tensioning devices backed off 1.0-3.25 inches during the test and were no longer providing proper tension to the net.

3. The 155MM Projectile pallets moved 2-6 inches toward the passenger side of the trailer and an additional 0.75 inches toward the cab during testing.
4. The top pallets (Prop Charges) moved 1.5-2.0 inches toward the passenger side.
5. Inspection following the completion of the Washboard Course revealed that the payload overhung the side of the CROP.

**Photo 4. Washboard Course Testing of Smart Tie-Down System with SCL #23 Load Bay.**

**Photo 5. Backing off of Load Tensioning Devices.**
